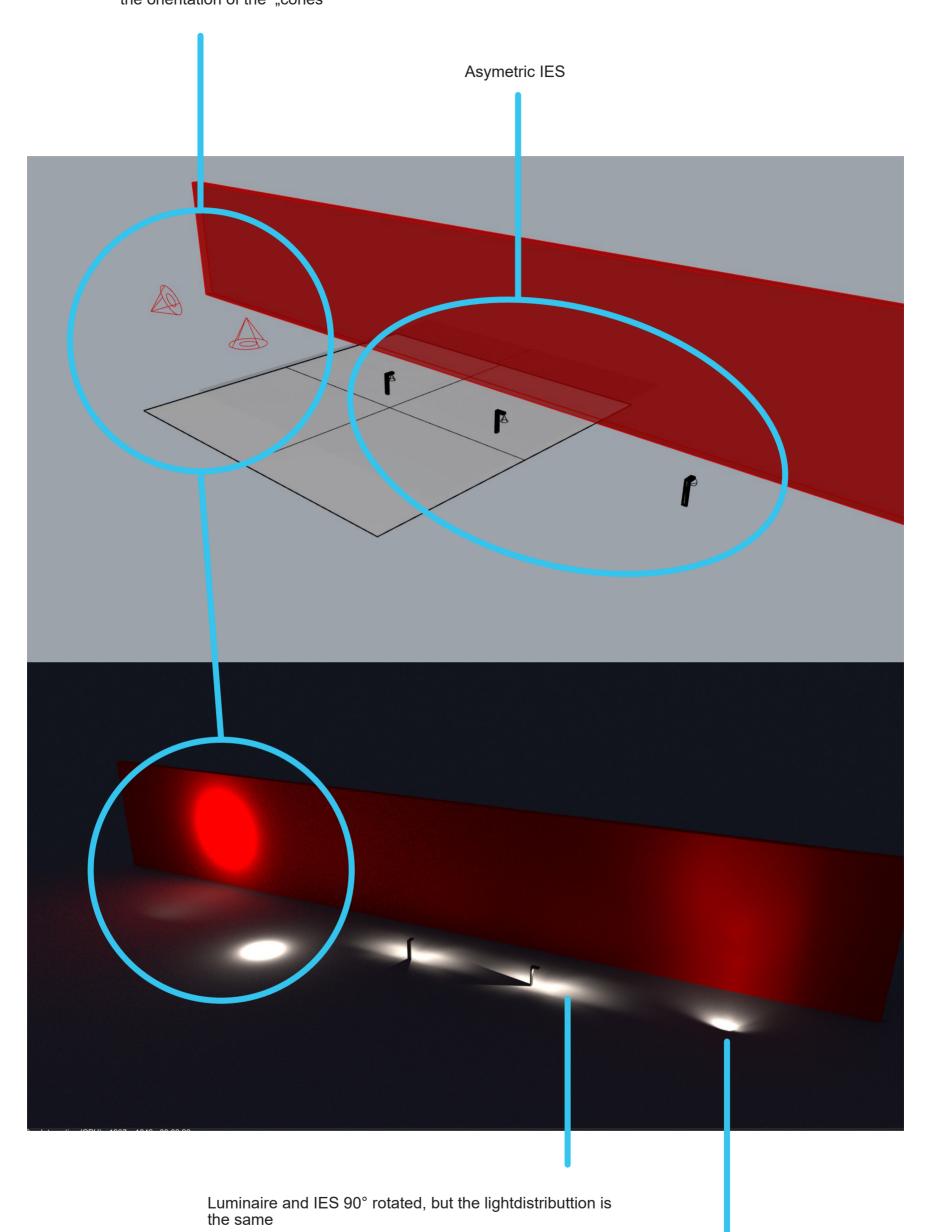
IES file 90° declined ==> light distribution not what it supposed to be (no light on the floor + asymetric on the wall
